Reports on technical fixes and progress reported for the electronic monitoring trial in the SNA1 trawl fishery

Electronic monitoring trial in the SNA1 fishery - Summary of progress with technical issues and their solutions

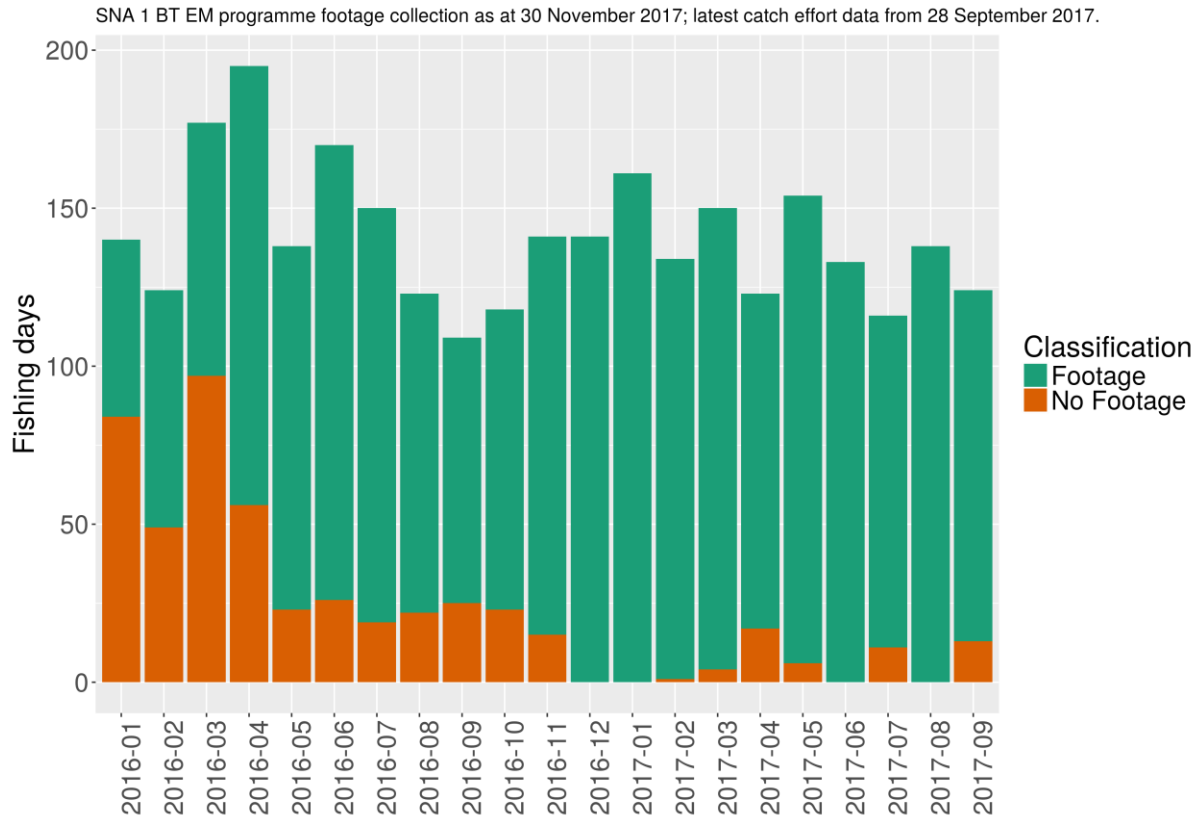
Graph of footage collection

The graph shows the days of fishing conducted by the core SNA 1 EM fleet (vessels catching more than 5 tonne of snapper annually) since the project began, and illustrates whether or not EM footage was obtained. The number of fishing days recorded has steadily improved as cameras have been installed on vessels and as technical issues have been resolved.

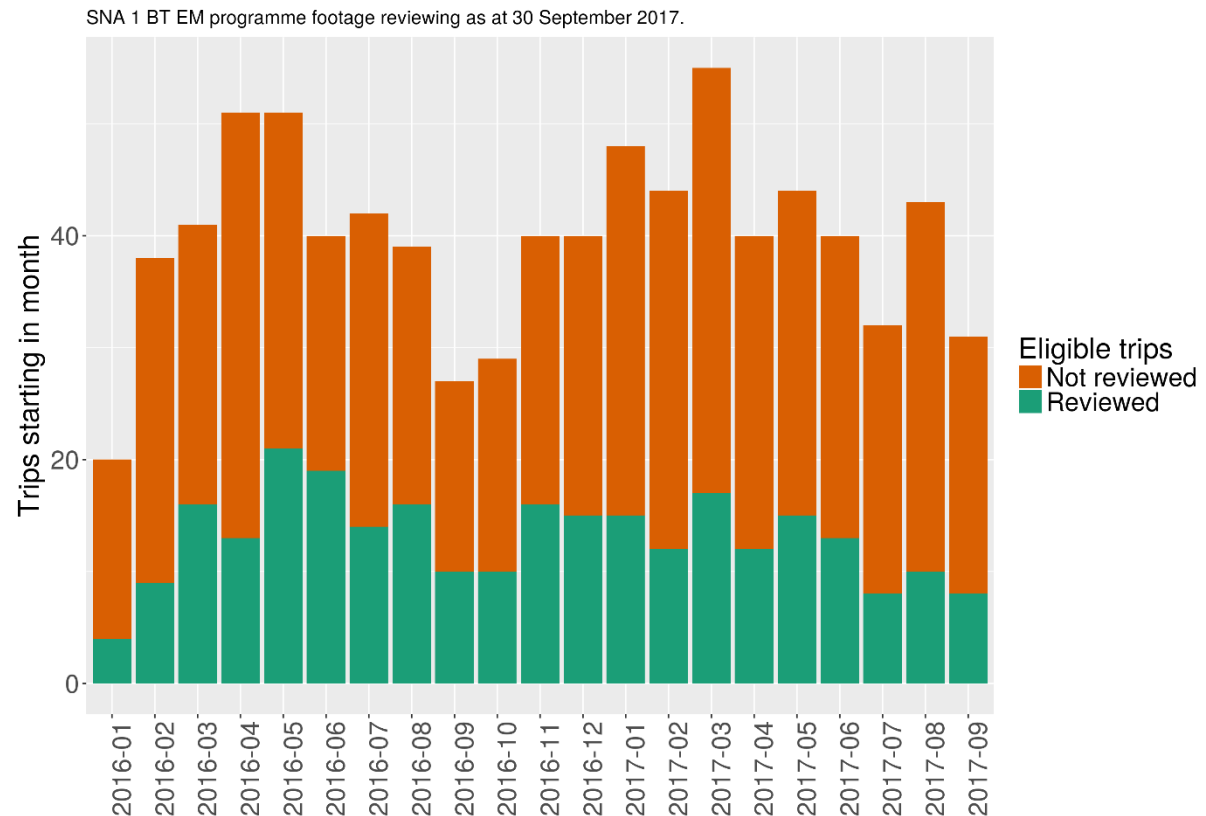
Graph of reviews achieved

The graph below shows the number of eligible fishing trips conducted by the core SNA 1 EM fleet and the number of trips which have been reviewed by month since the project began. The number of eligible trips reviewed in the most recent months is incomplete due to the time required for footage collection, footage transfer and cataloguing, identification and selection of footage “slices” for review, review of footage “slices” and quality assurance. The number of trips reviewed by Trident has met the target of 30% of eligible trips.
